CITY OF
SIDNEY

REPLACEMENT CRITERIA FOR CURB AND GUTTER

REVISIONS: DATE APPROVED
06/03/2020
PAGE No.
300-22

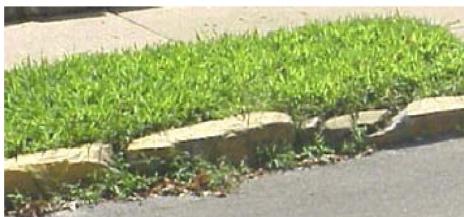
EXAMPLE: Settlement / Vertical Offset

(1) Curb and/or gutter having differential settlement or heaving at joints that create a vertical offset of 2 inches or more at any point along a joint,...or multiple joint gaps greater than 3 inches

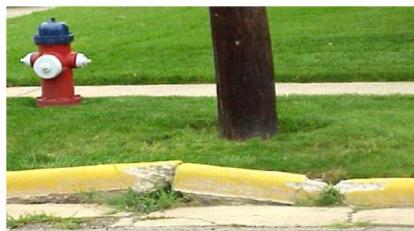
EXAMPLE: Extreme Slope

(2) Curb and/or gutter having a slope of more than 2 inches per foot in any direction from a road or natural grade that creates a discontinuation in the curb or gutter.

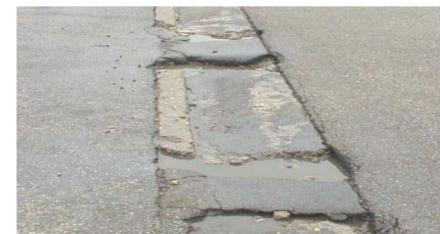
EXAMPLE: Large Holes in Surface

(3) Curb and/or gutter having holes or depressions in the surface that are in excess of 1 foot by 1 foot by 2 inches deep.

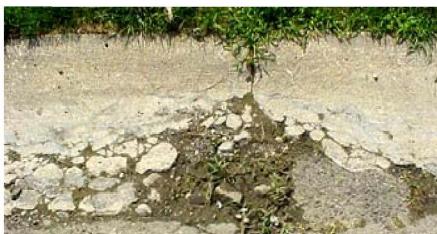
EXAMPLE: Deteriorated

(4) The surface of a curb and/or gutter having 50% or greater of its surface continuously spalled or deteriorated within a 10 ft poured section.

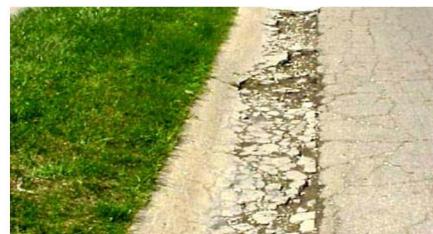
EXAMPLE: Exposed aggregate

(5) Curb and/or gutter sections that have crushed stone or gouges that continuously expose aggregate for 50% or more within a 10 ft poured section.

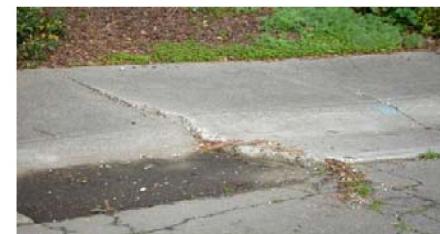
EXAMPLE: Asphalt repairs

(6) Curb and/or gutter sections that have been previously patched with a bituminous material or materials other than concrete for 50% or more within a 10 ft poured section. (This does not include a street or section of a street originally installed or reconstructed with asphalt curbing and/or gutter.)
